TEST REPORT

No. P 0578/13-530-1

FIRE RESISTANCE TEST of
non-loadbearing gypsum acoustic plasterboard
partition

INDEX acoustic wall

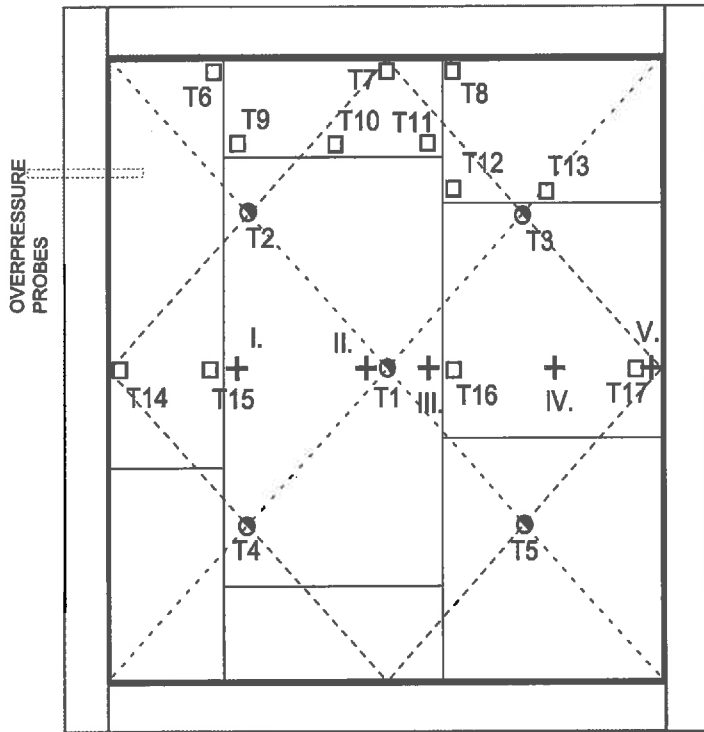
TEMPERATURE AND DEFLECTION MEASUREMENT POINTS

Thermocouples NiCr-Ni

1-6... in the furnace

1-17... on the unexposed face

I-V... deflection measuring points

Sketch of the unexposed face temperature rise measuring points is in enclosure No. 1.

Measuring point No. 1at the centre of the specimen

Measuring points No. 2 to 5at the centre of each quarter of the specimen

Measuring point No. 6, 8at vertical joint, 15 mm from the top edge
 Measuring point No. 7.....at mid-width, 15 mm from the top edge
 Measuring point No. 9 - 13in the upper half of the specimen, 15 mm from vertical or horizontal joints
 Measuring point No. 14at mid-height, 15 mm from restrained vertical edge
 Measuring point No. 15, 16at mid-height, 15 mm from vertical joint
 Measuring point No. 17at mid-height, 100 mm from free vertical edge

Deflection of the specimen (measuring point II and IV) and joints (measuring point I and III).
 The positive values mean bending of the specimen into the furnace.

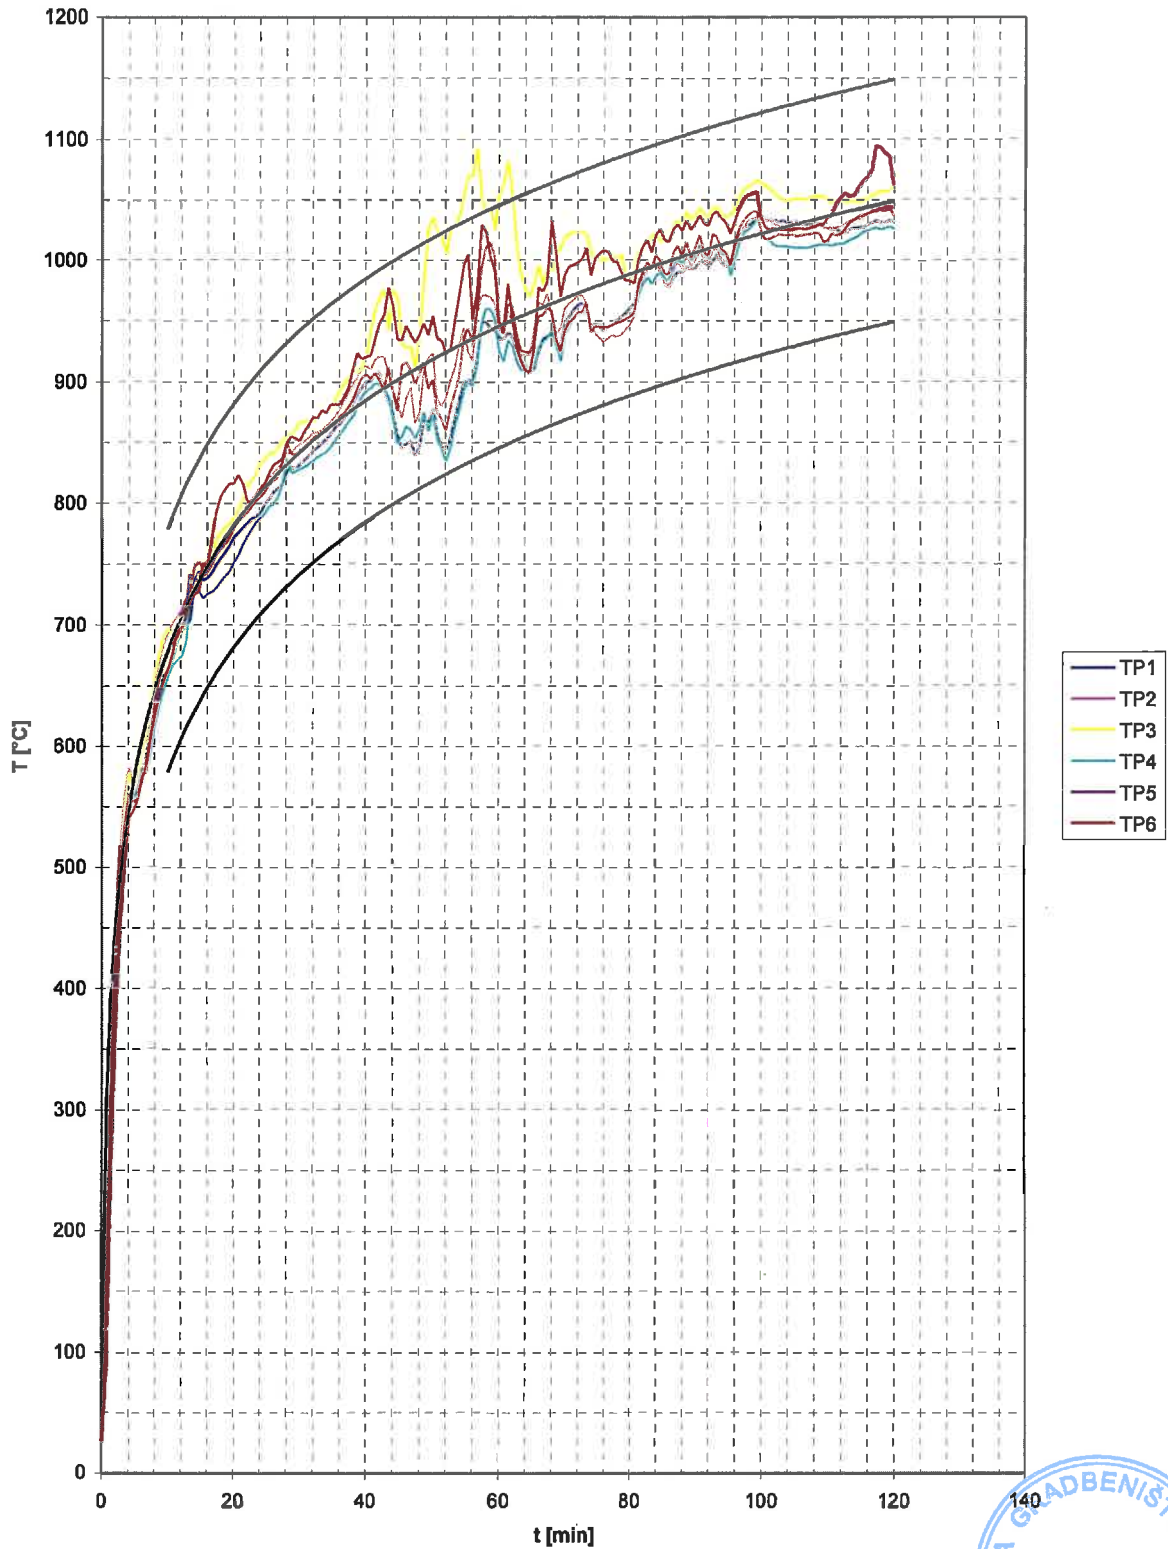
FURNACE TEMPERATURE RISE

P13-069 Temperature rise in the furnace

The temperature inside the furnace was measured by means of six plate thermocouples NiCr-Ni. These thermocouples extended through the furnace wall into the burning space to approximately 100 mm from the exposed face of the test specimen. The furnace temperature was continuously controlled such that it follows the standard time-temperature curve within the accuracy specified in SIST EN 1363-1:2012:

Diagram of the temperature inside the furnace is in the enclosure No. 2.

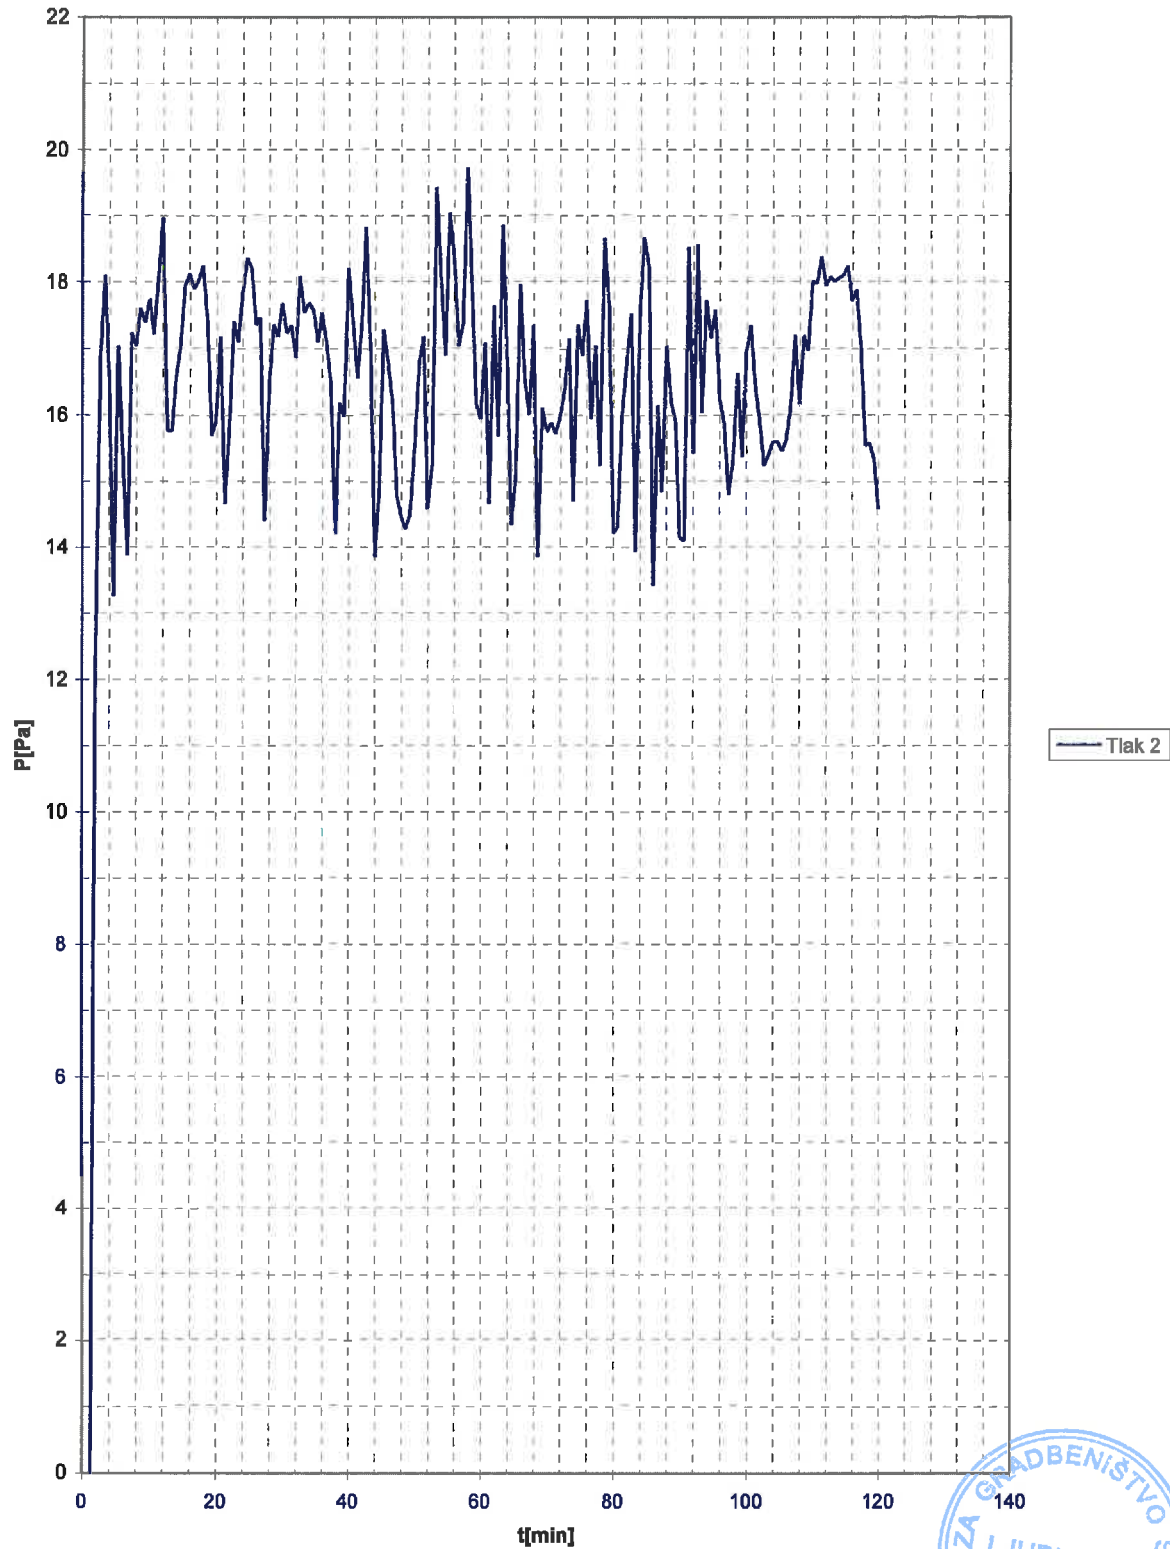
OVERPRESSURE IN THE FURNACE

P13-069 Pressure in the furnace

The overpressure inside the furnace was measured by means of one pressure transducers Ashcroft XLDP3, computer and appropriate software. It was controlled by means of damper inside the exhaust in such a way that the overpressure inside the furnace at 2500 mm of specimen height was approximately 17 Pa.

The diagram of the overpressure is in enclosure No. 3.

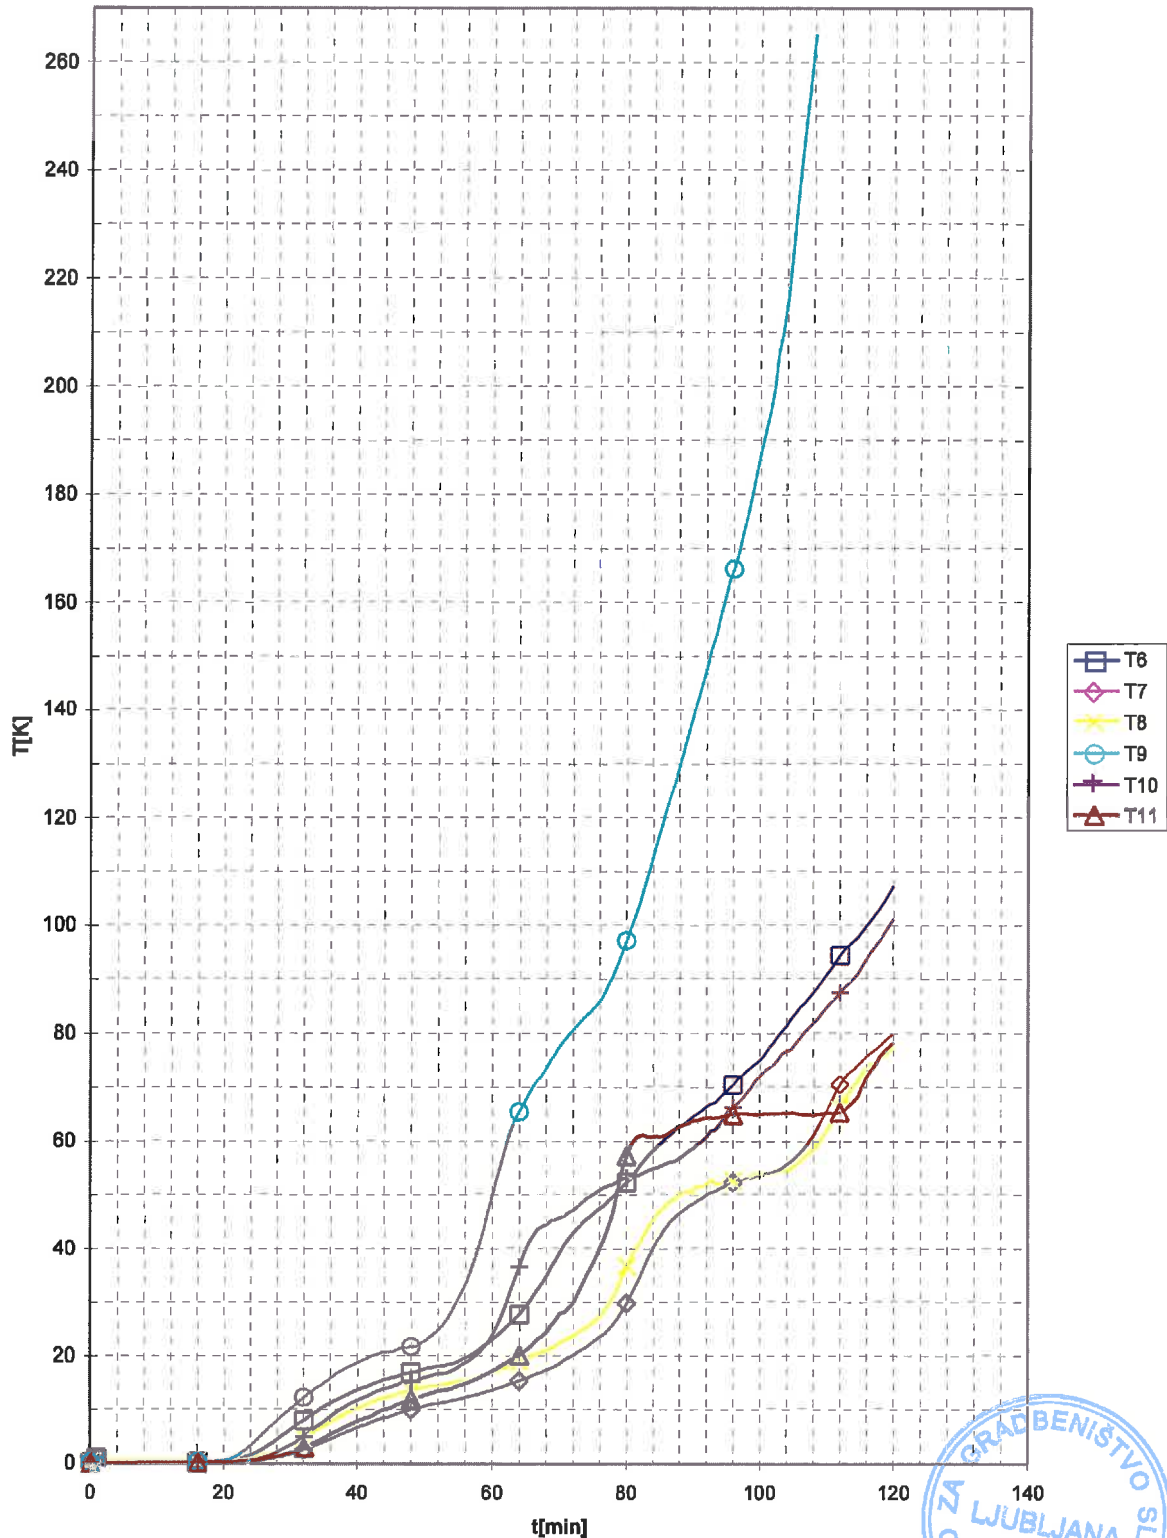
TEMPERATURE RISE ON THE UNEXPOSED
FACE

P13-069 Temperature rise on the unexposed face

The diagrams of the unexposed face temperature rise measurement are in enclosure No. 4.

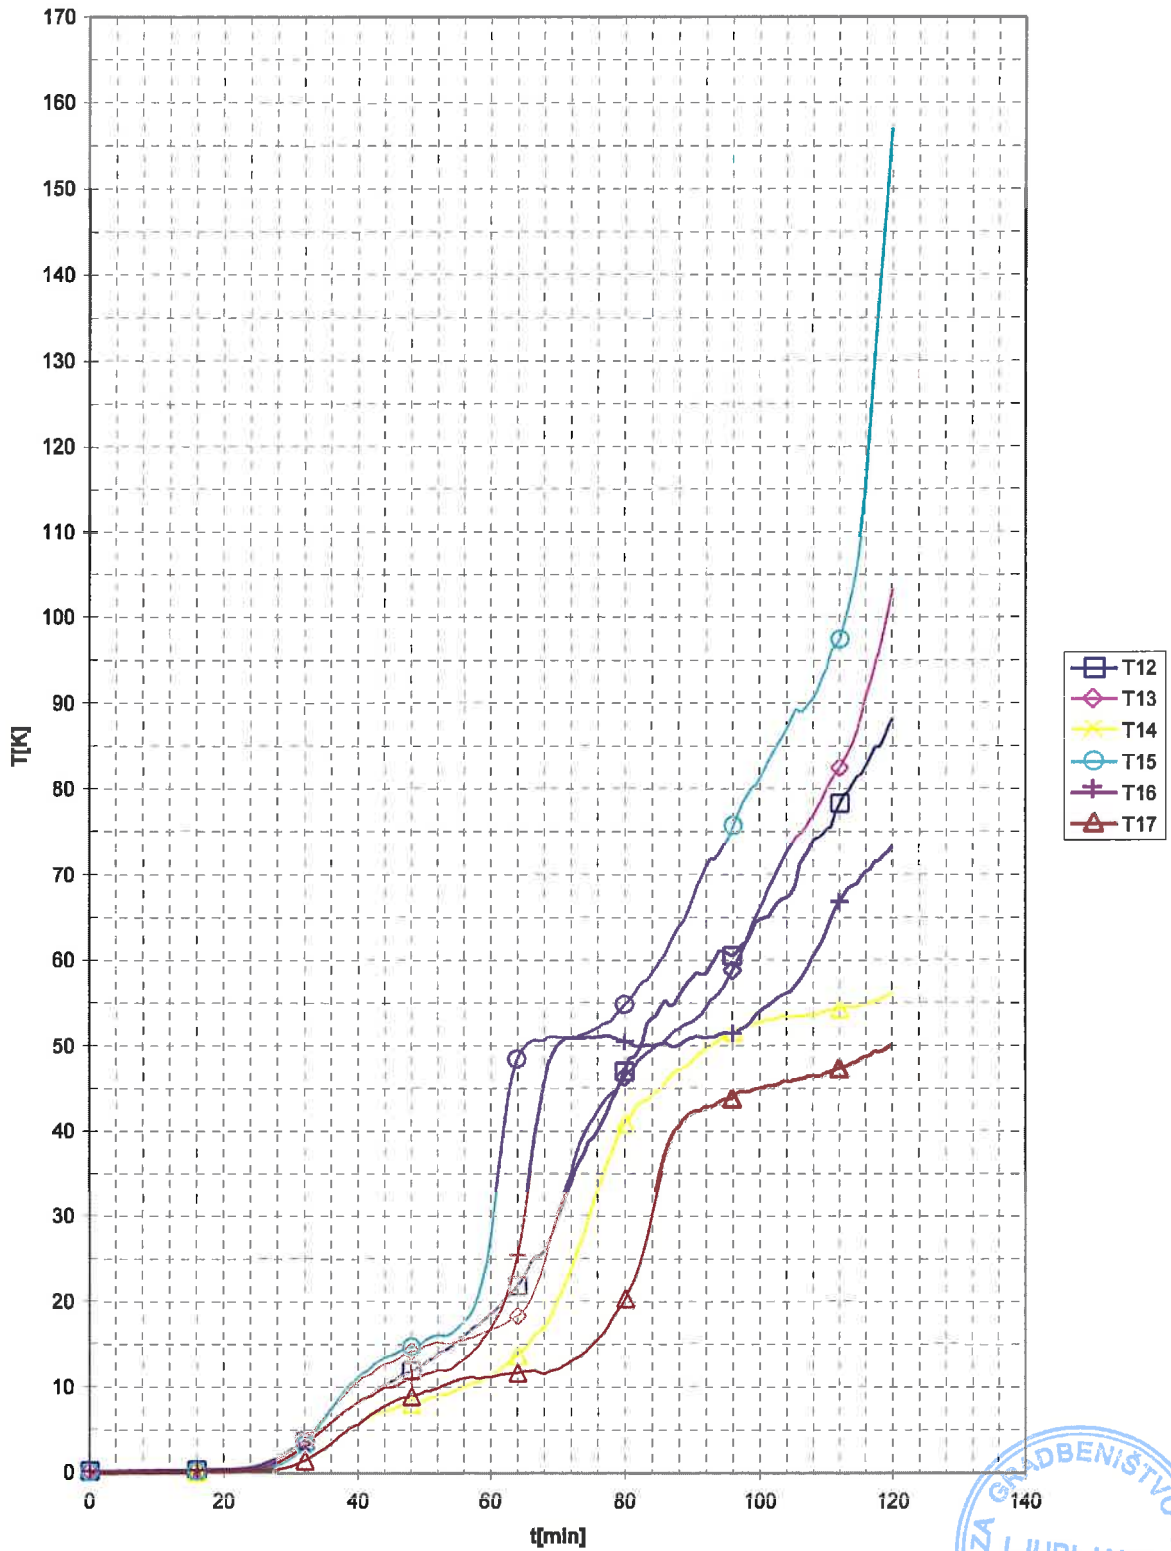
TEMPERATURE RISE ON THE UNEXPOSED FACE

P13-069 Temperature rise on the unexposed face

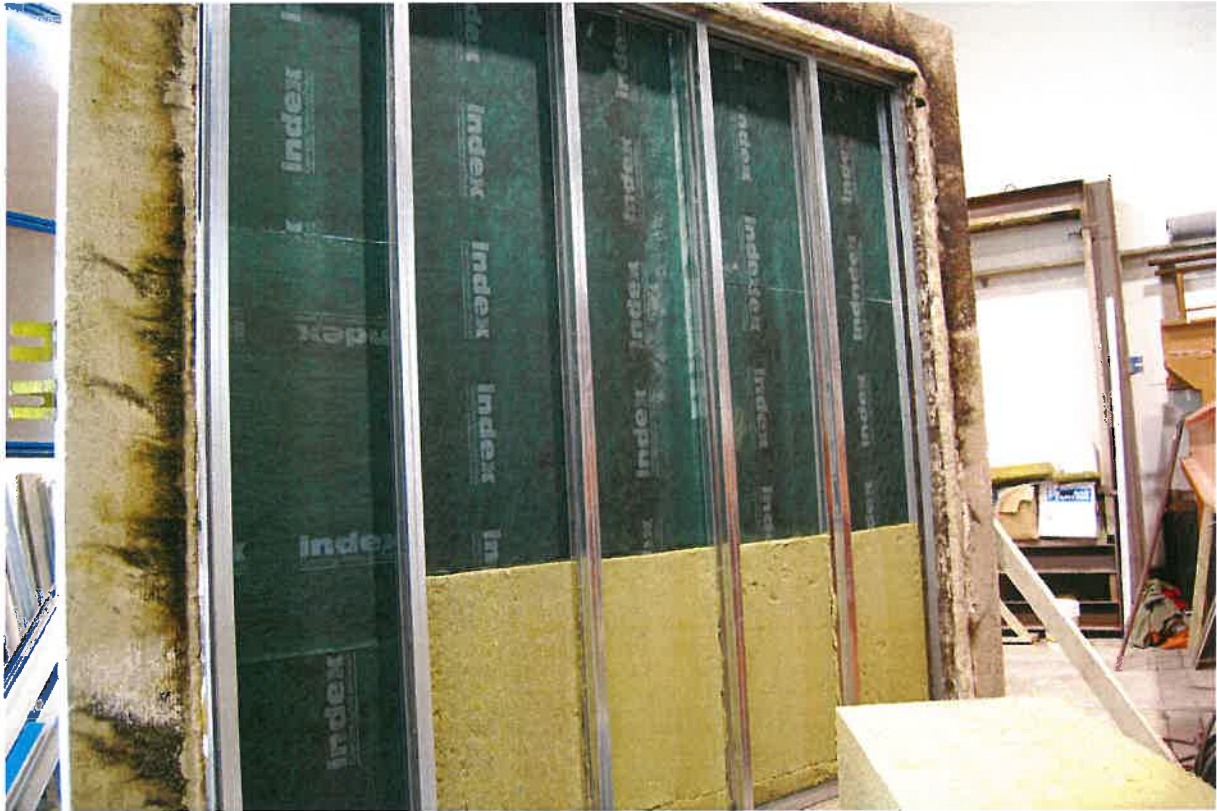
Photo No. 26932d-02: Mounting of the specimen before the test

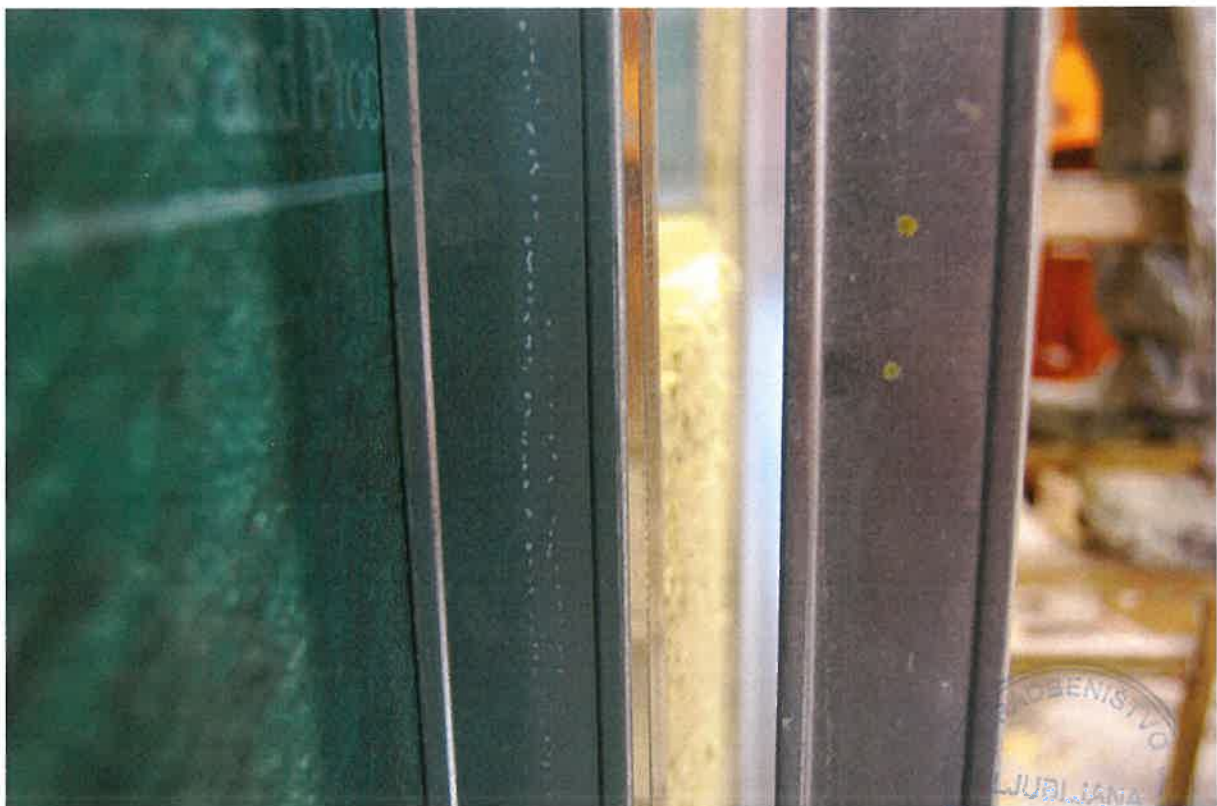
Photo No. 26932d-06: Gap between frameworks

The construction of the wall specimen of dimension 2963 × 3015 × 186 was made on two metal frameworks, each constructed of two horizontal and six vertical 50 mm deep metal profiles. Top, bottom and one edge vertical profile were fixed to the testing frame. One edge stud profile was not fixed to the side edge of testing frame. Distances between stud profiles were 600 mm, except the distance to the free-edged stud profile was 540 mm. The gap between the free-edged stud profile and the side edge of the testing frame was 52 mm wide. The distance between two frameworks was 30 mm.

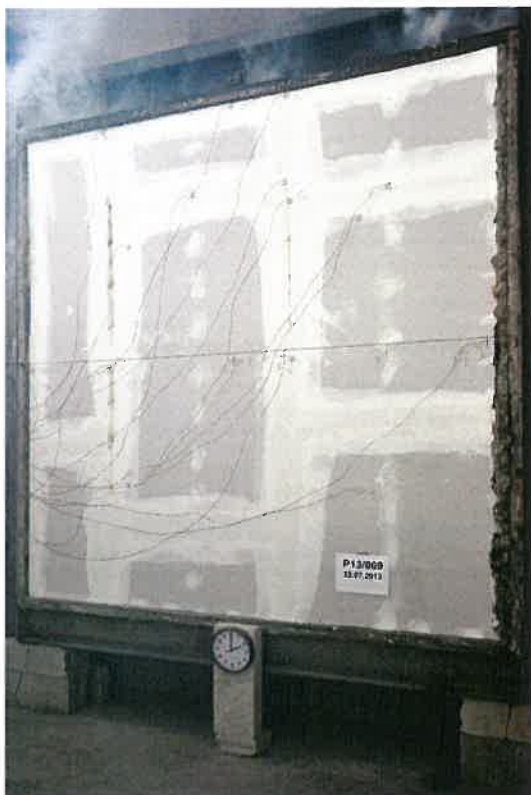
Photo No. 26924d-25: 120th minute of testing time

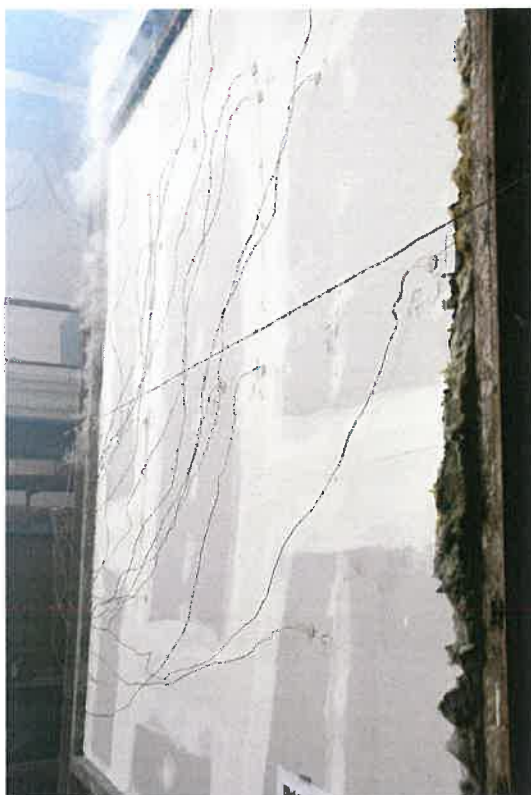
Photo No. 26924d-27: 120th minute of testing time
